# VALVES AND VALVE PROBLEMS

**MR. A. PERKINS (MSFC)**

## VALVES AND VALVE PROBLEMS

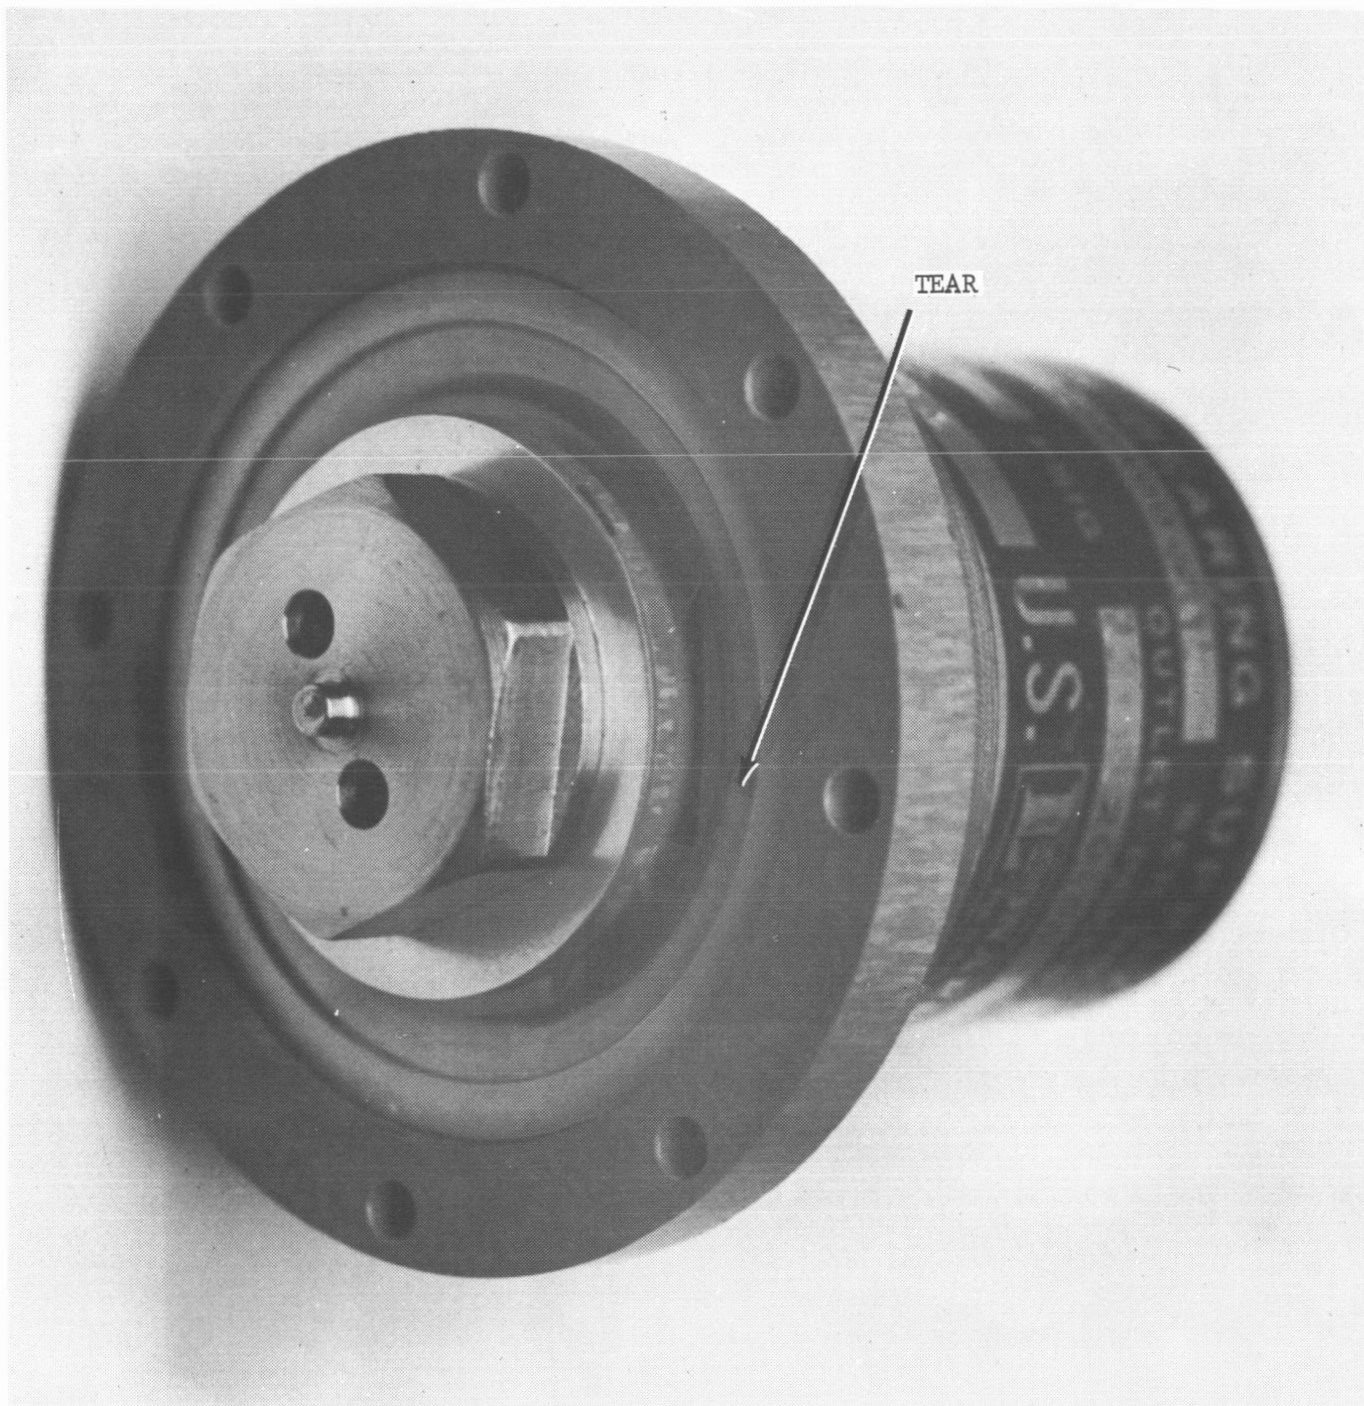
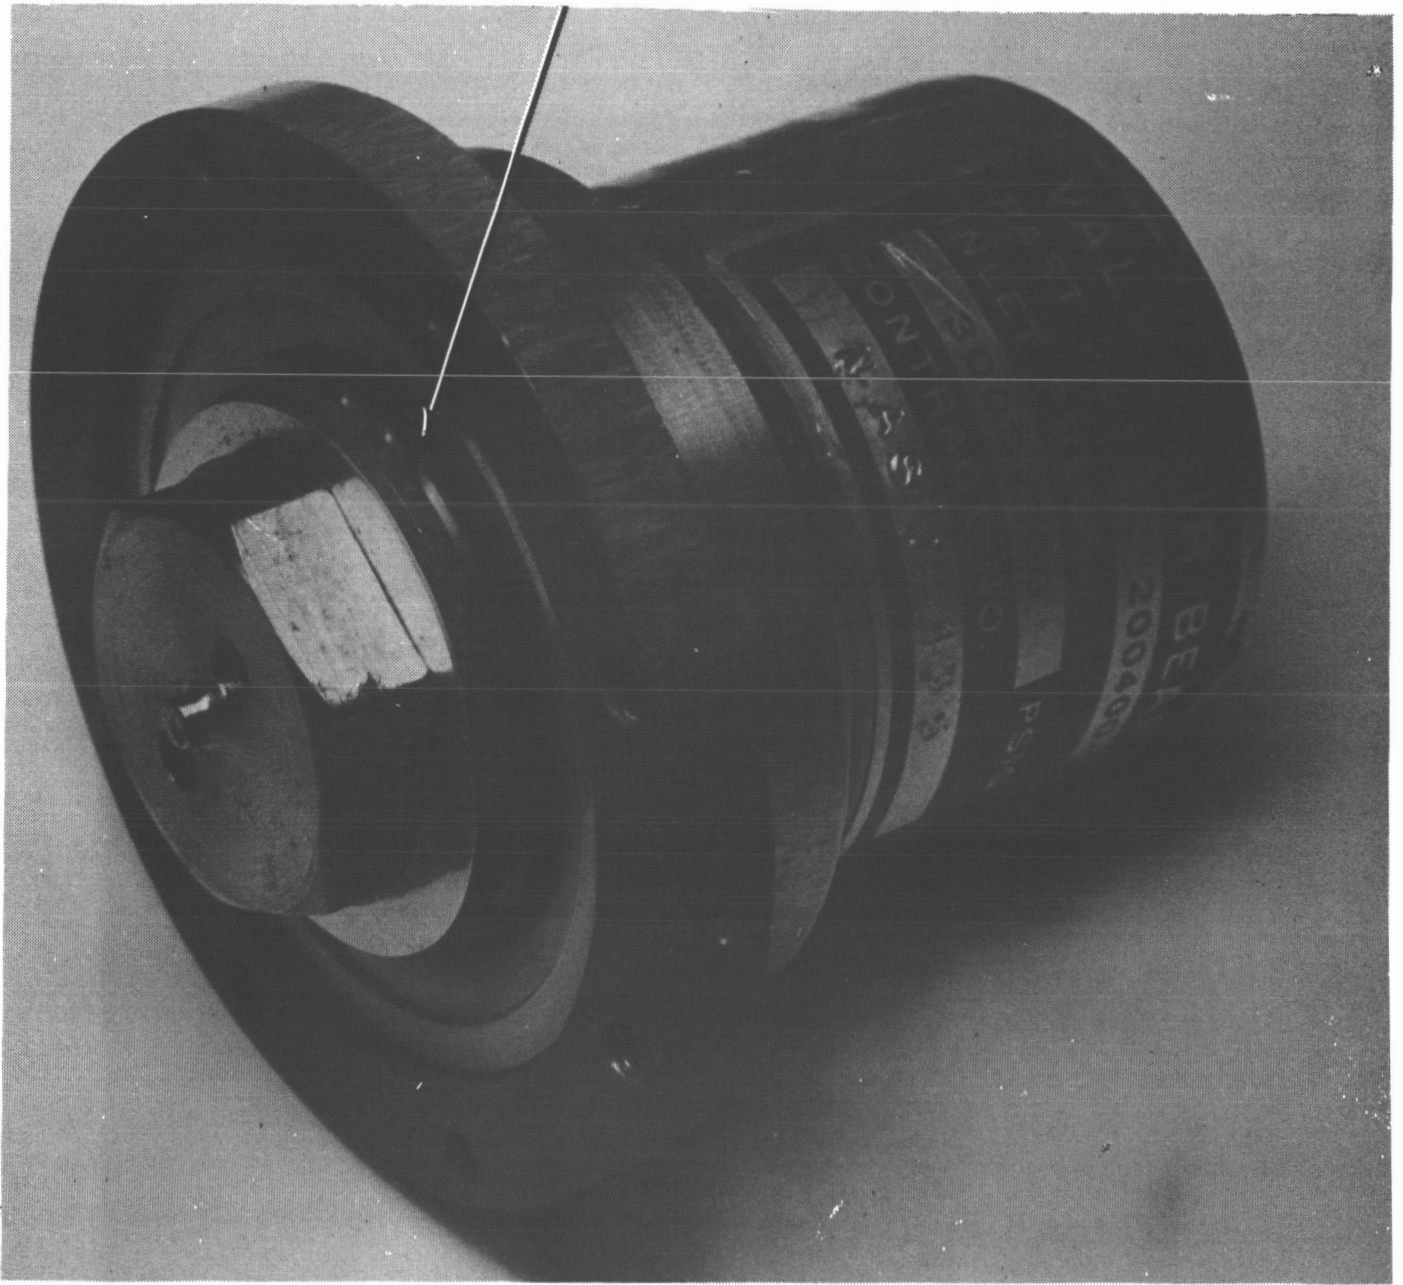
A failed diaphragm in the first stage end of the regulator is shown in Figures 7, 8, and 9. The diaphragm burst due to the sharp edge on the diaphragm

FIGURE 7. REGULATOR - FIRST STAGE PORTION - BROKEN SEAL

FIGURE 8. REGULATOR - FIRST STAGE PORTION - WRINKLED SEAL

FIGURE 9. DAMAGED REGULATION SEAL

retainer and wrinkles in the diaphragm itself. This problem was corrected by removing the sharp edge on the retainer and modifying the forming process of the diaphragm to eliminate the wrinkles.

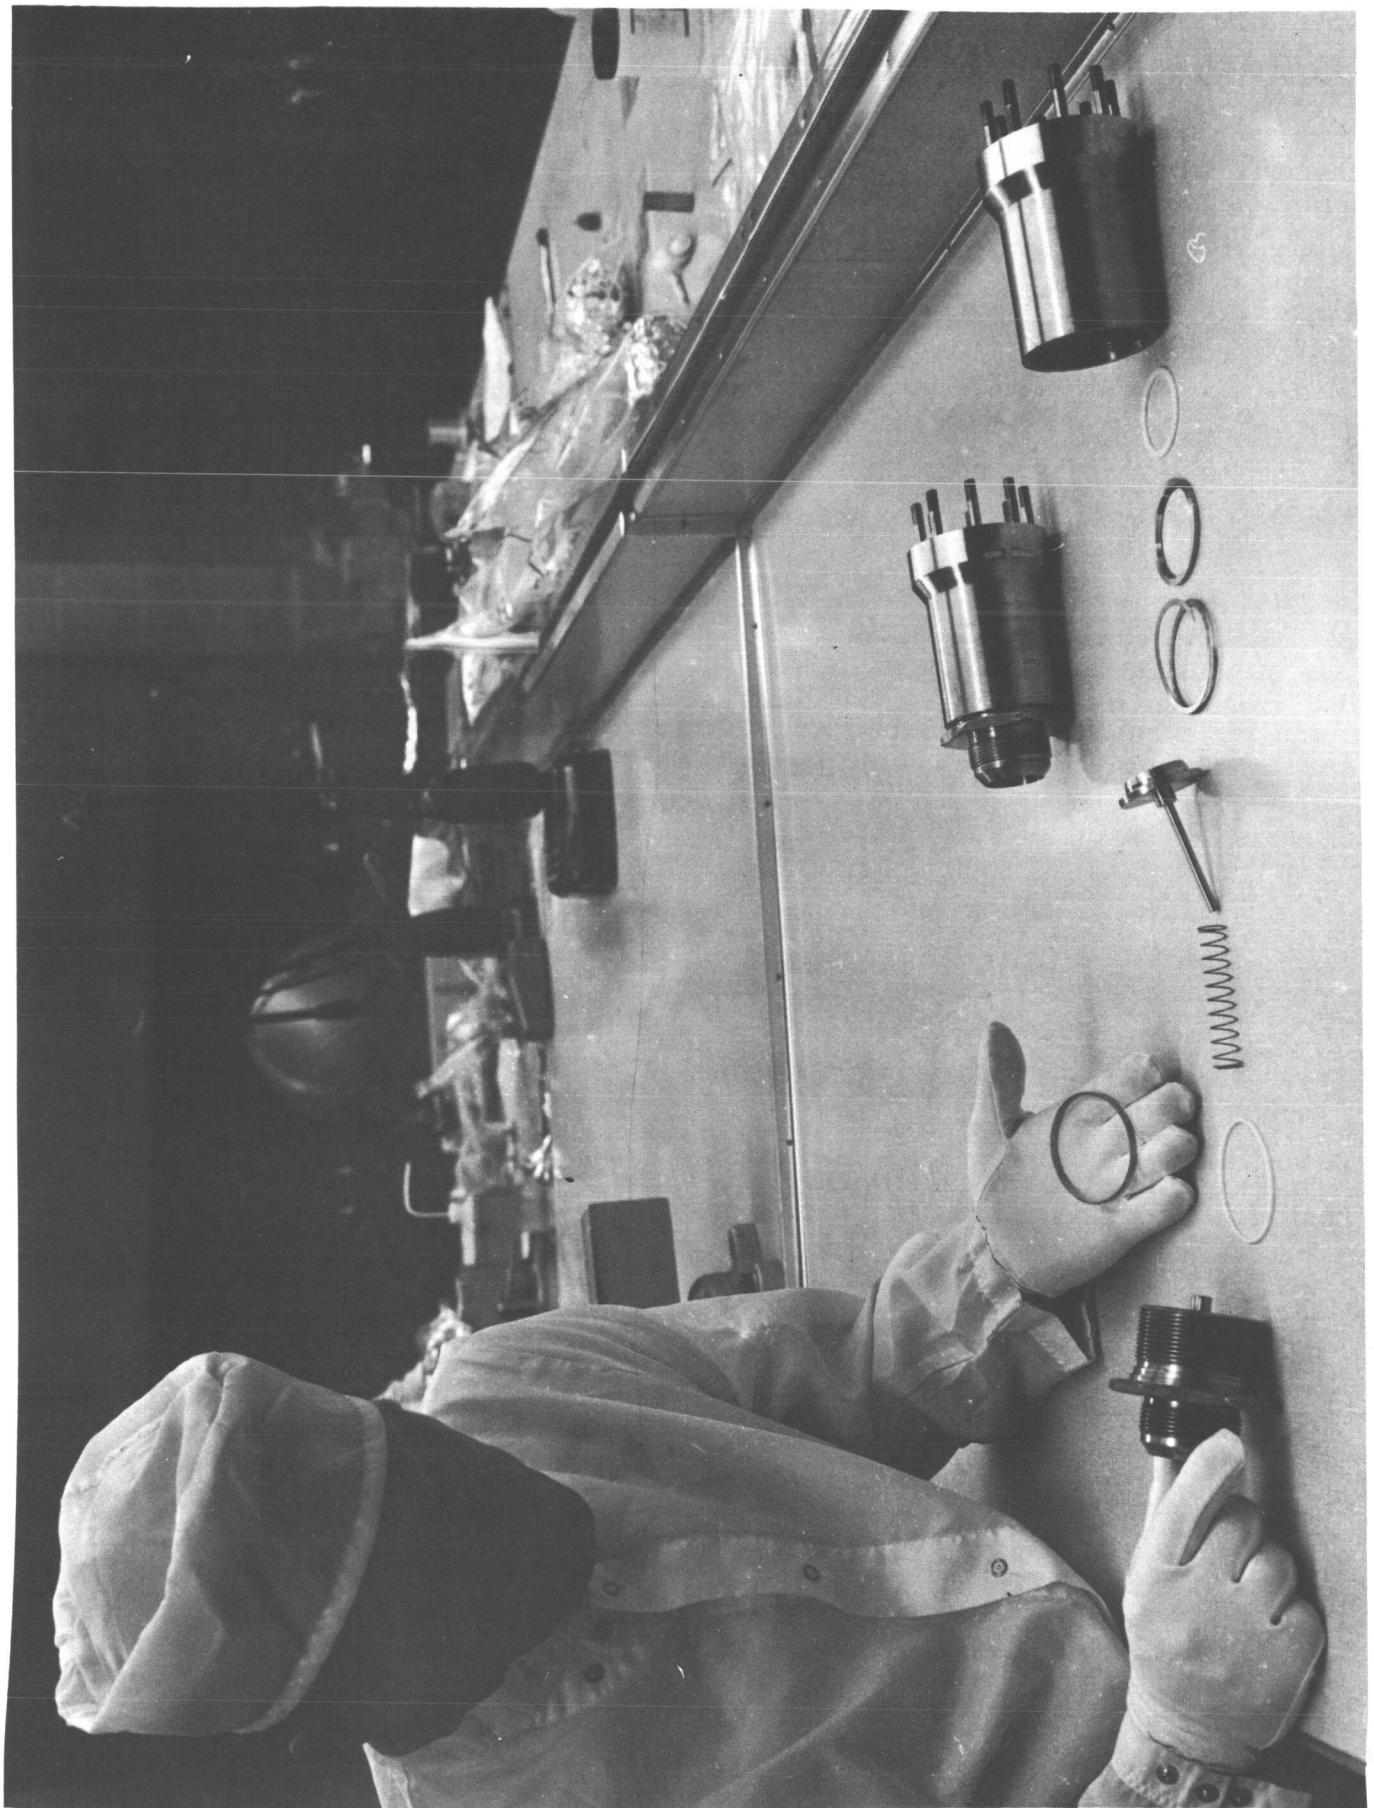
A problem was also encountered with the LOX Heat Exchanger Check Valve. The LOX containers on the Saturn Vehicle are pressurized during flight by LOX which has passed through the rocket engine heat exchangers. Within this pressurizing system, check valves are located between the heat exchangers and the LOX containers. On the Block I Saturn vehicles no major problems with these check valves were encountered, but on the Block II Saturn the check valves were exposed to a higher temperature which caused external leaking during the static firing of SA-5. This increased heat caused the Teflon seal between the valve body halves to flow out of shape causing the valve to leak (Figure 10). This problem was corrected by changing the material of the housing seal from Teflon to copper (Figure 11).

FIGURE 11. REPLACING OF TEFLON SEAL WITH COPPER SEAL

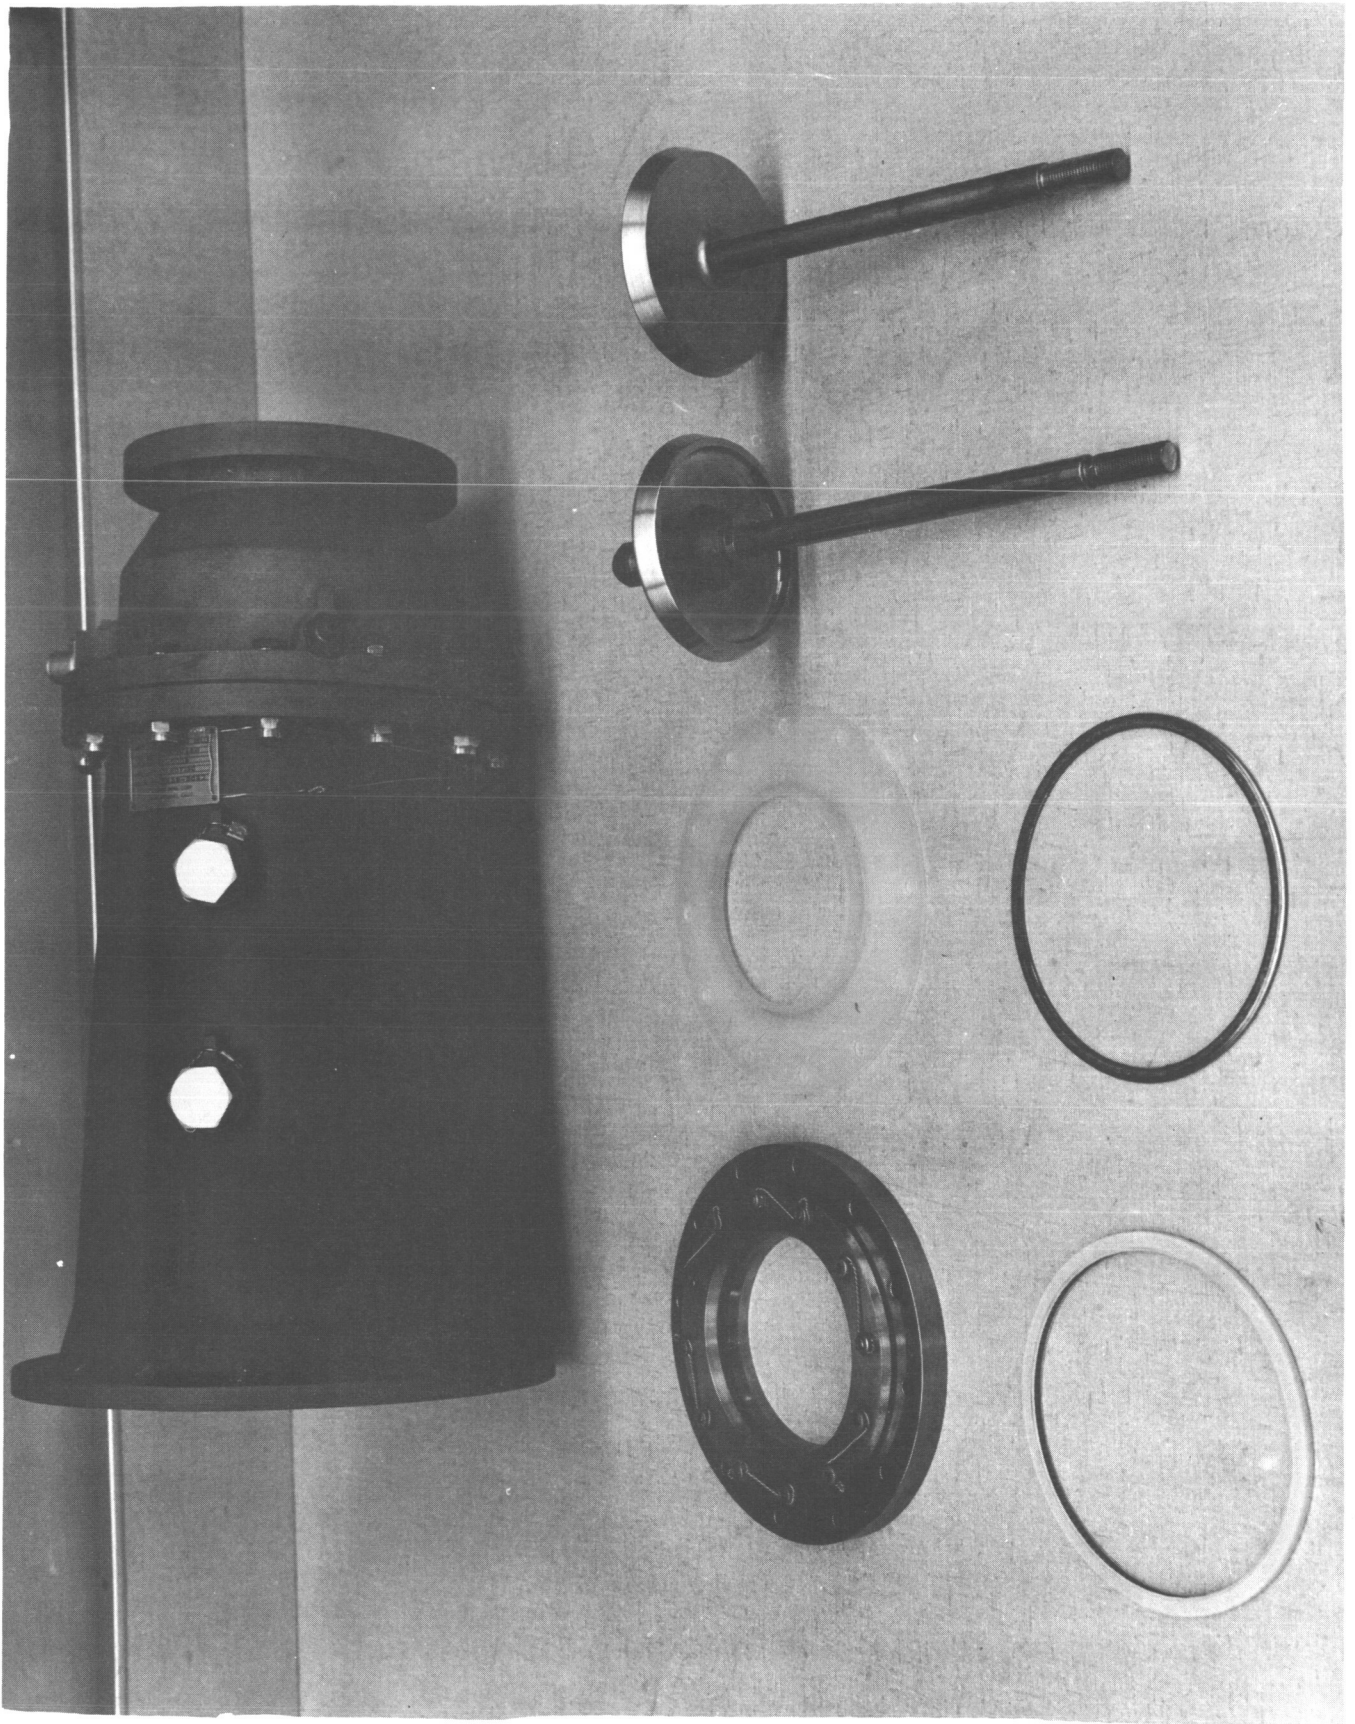
The Saturn LOX Container Pressure Relief Valve (Figure 12) has experienced more problems and a higher rejection rate since the Redstone vehicle than any other valve. Most of these problems were excessive leakages at cold temperatures.

FIGURE 12. SATURN LOX CONTAINER PRESSURE RELIEF VALVE

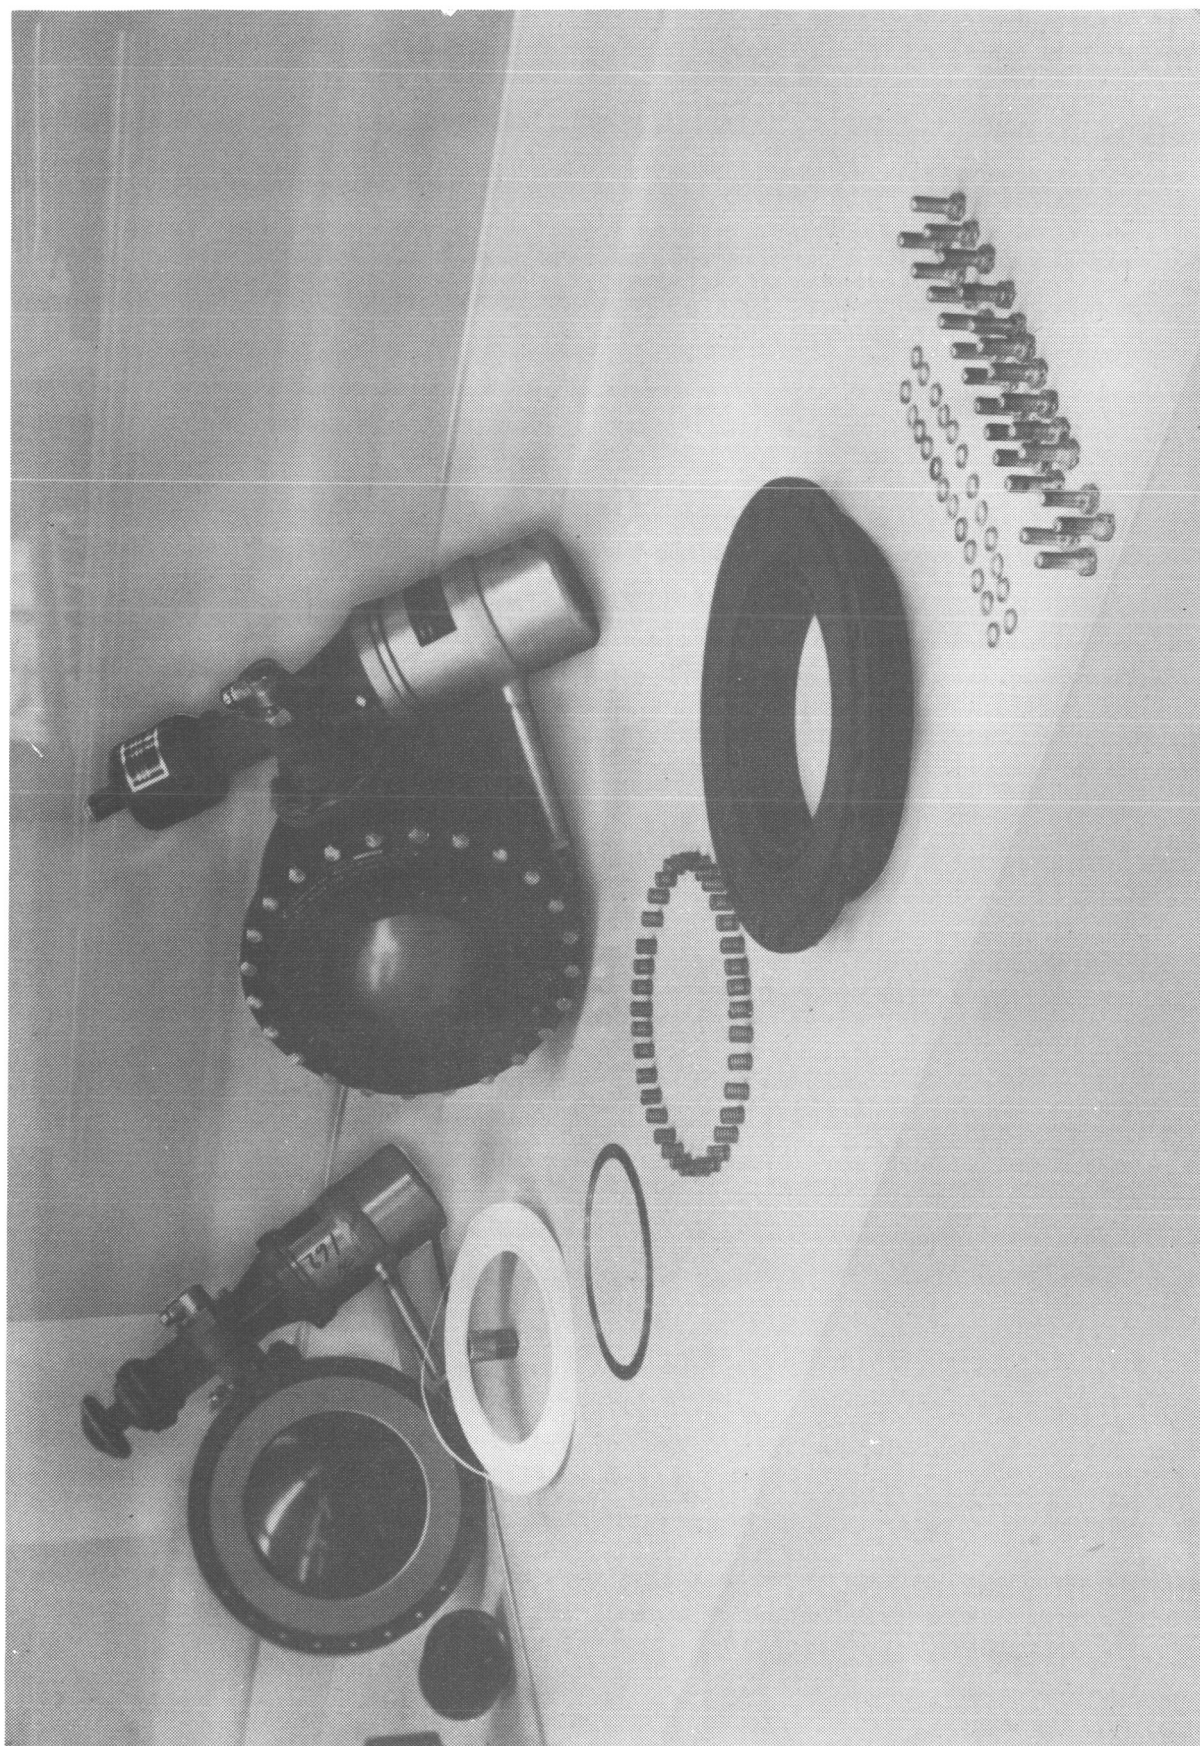
One problem with this valve occurred when the main seal leaked LOX during the static firing of SA-5. The cause of this failure was found to be a split in the outer portion of the main seal (Figure 15). The cause of the split was found to be the serrated design of the flange which secures the O.D. of the main seal. These male serrations would cut into the seal to prevent leakage. Because the main seal is made of Teflon, which has a tendency to flow under pressure, the male serrations cut sufficiently into the seal so that the pressure imposed on the valve during static tests caused the seal to split. The solution to this problem was to reverse the serrations. The male serrations were removed and female serrations machined into the flange (Figure 16).

FIGURE 15. CONTAINER FILL AND DRAIN VALVE WITH DAMAGED SEAL

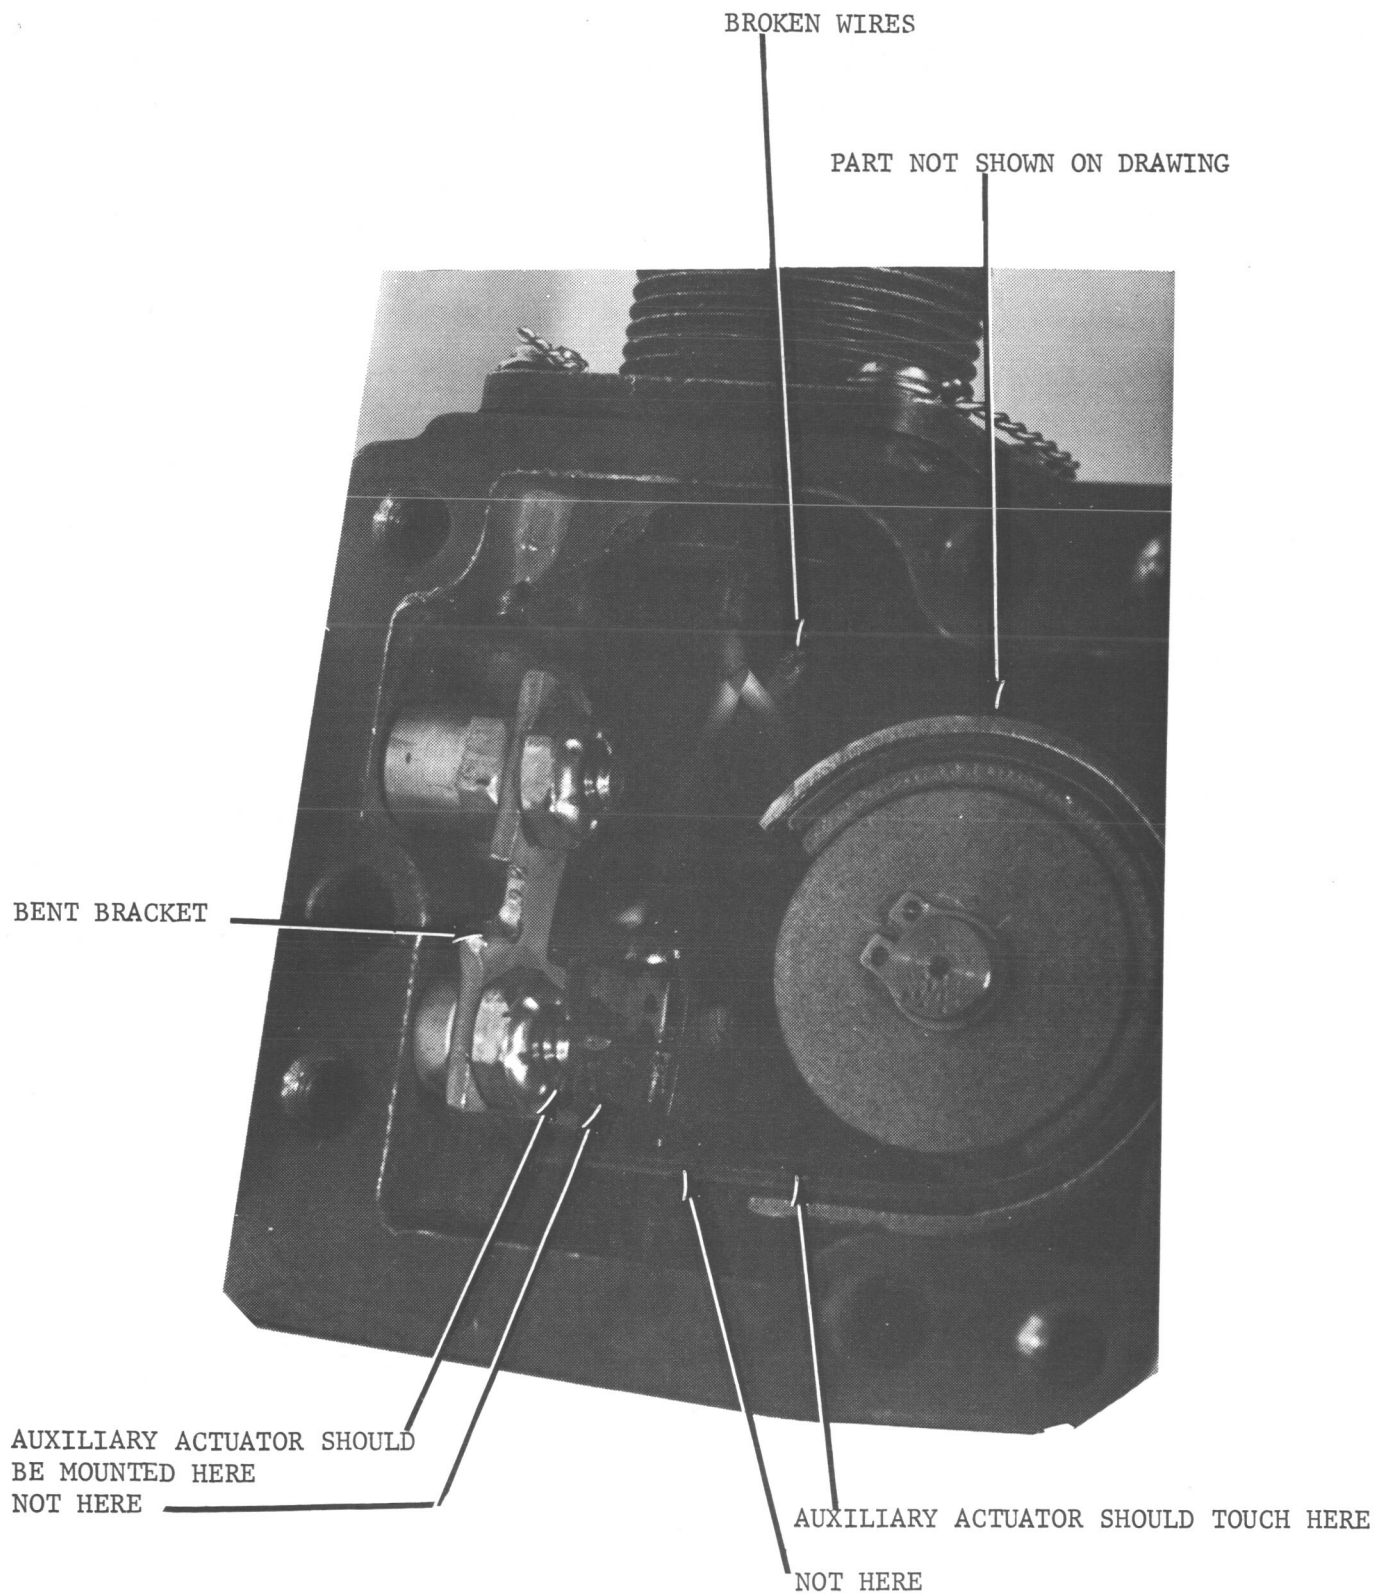
Figures 20 and 21 show the poor quality of two different type pressure switches that had failed on two of the Saturn Vehicles during checkout.

FIGURE 21. DEFECTS IN PRESSURE SWITCH
